# LIMITED SCOPE EVALUATION OF BUILDING EXTERIOR - FINAL

**Herschler Building**

125 W. 25<sup>th</sup> Street

Terracon Project No. F6149127

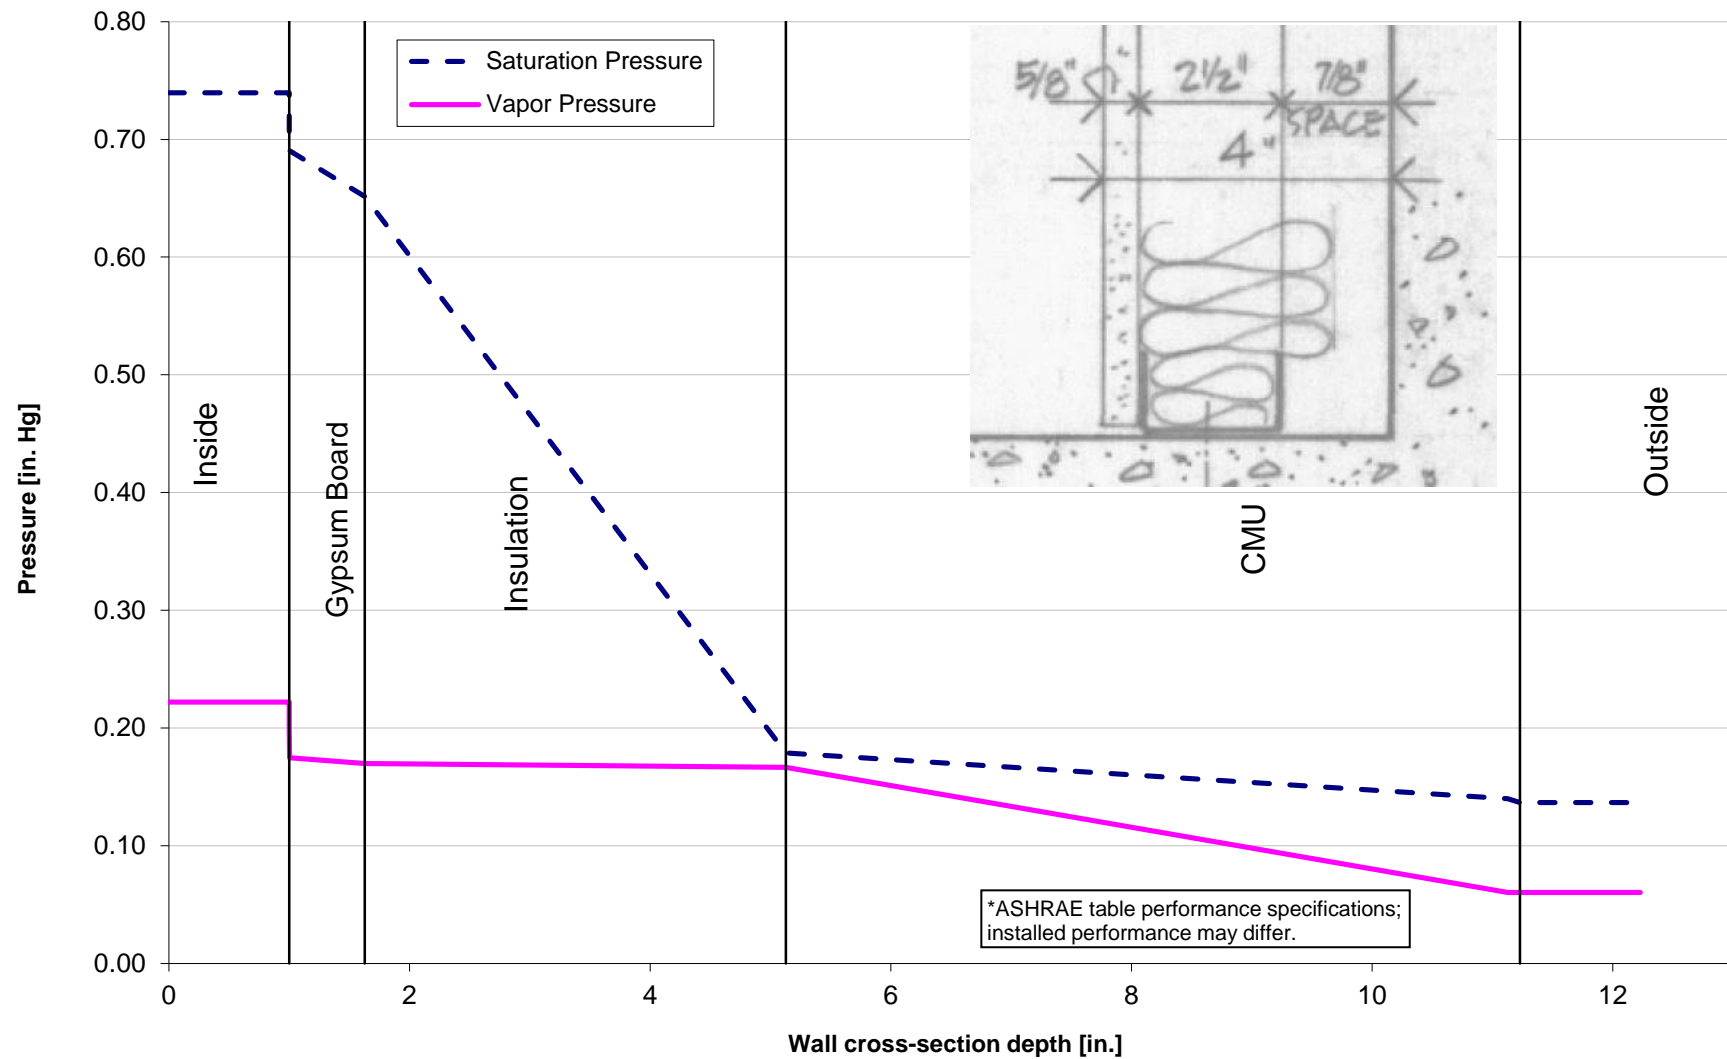
### Herschler Study 1 - Case 1 - Interior (70°F, 30%), Exterior (26°F, 44%)

Terracon analyzed five (5) different wall assemblies to calculate the potential of condensing water vapor. Dew point studies of multiple existing wall assemblies requested by HDR Architects. For each wall assembly analyzed, three (3) separate temperature gradients were considered and graphed. Moisture was anticipated to be present where the vapor pressure exceeded the saturation pressure. Please refer to Appendix A for dew point calculations and corresponding graphs.

Each graph assumes “as-built” conditions. No weathering effects (e.g. sealant degradation) are considered in the calculations. Because the conditions analyzed represent what is essentially a newly-installed condition, the analysis represents “bounding conditions”, in which design deficiencies are considered separately from weathering effects.

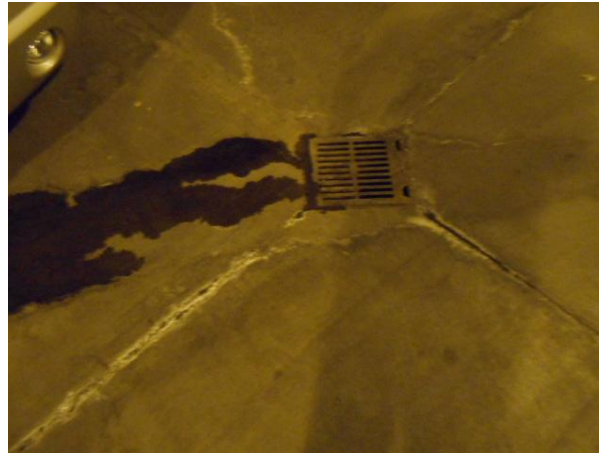
**Photo #46** Surface drain in the parking garage.
